Landscape Assessment:

Observations and Revitalization Recommendations

Kalele Kai Condominiums

January 22, 2015

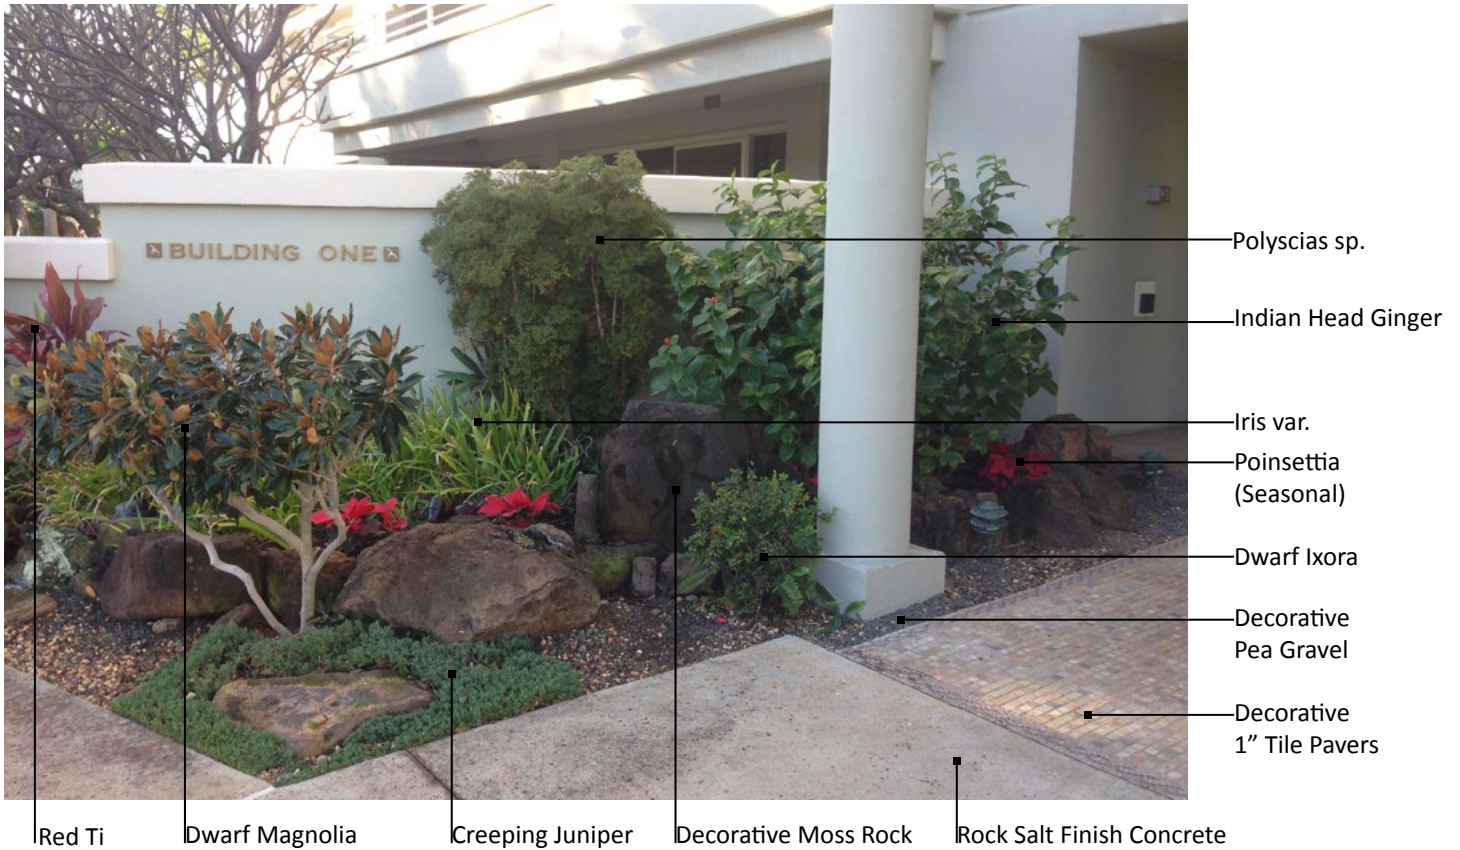
Building 1 Entry (L)

Observations:

The general composition of the planting spaces are good. The moss rock placement allows an elevated area along the wall creating a terraced effect. The varied sizes of the moss rock help to convey a more “natural effect.” The layout location of the boulders also act as a containment for planting and may also allow for better percolation and drainage. With the acceptance of the “seasonal” placement of the Poinsettia, there are approximately 7+ different species of plants in about a 100sf area. The planting seems to reflect different “cultural themes” and planting “trends.” i.e. Japanese/Topical and Old Fashioned/Contemporary. The decorative pea gravel and decorative tile pavers at the entry also differ from the other two building entries. This entry has the most “robust” appearance of the three.

Recommendations:

Reducing the number of species would help to “calm” the presentation of the entry. The moss rock boulders could remain in place as-is. Also selecting plants of a consistent palette would also help to appease the eye. For example, if the design intent is to be “Japanese” then all plants of the pallets should be of that “style” or visual quality. The decorative multi-colored pea gravel can appear a bit “messy” due to the small texture and multi-color. The river rock as the other entries have may be a good alternative.

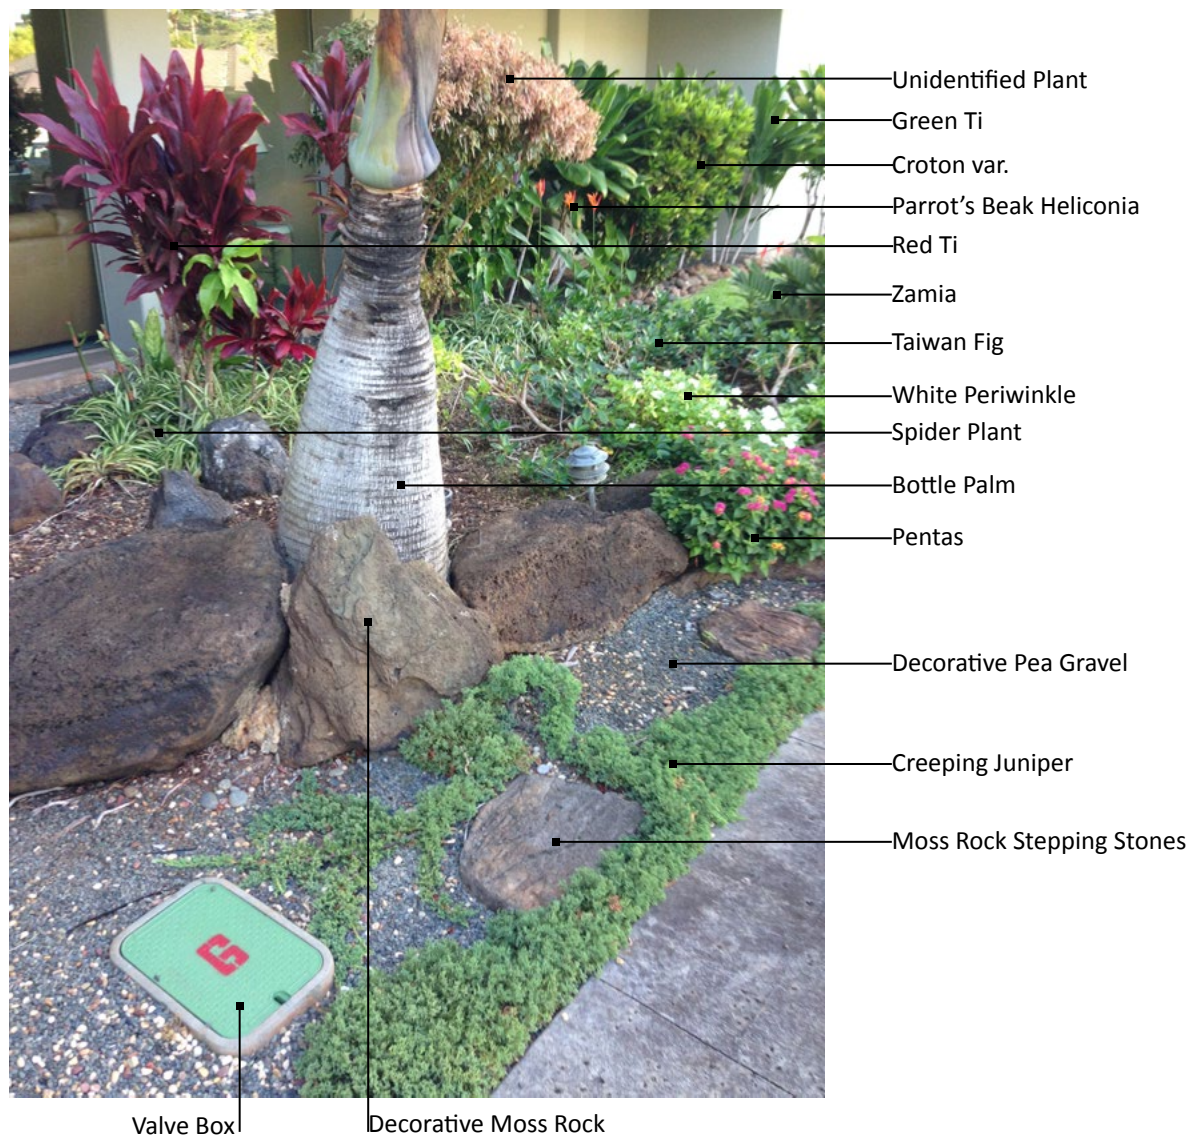
Building 1 Entry (R)

Observations:

Similar to the opposing side, the general composition of the planting spaces is good with the moss rock placement elevating a planted area as well as the other reasons mentioned for the left side. Also similarly to the left side there are many different species with only one or two that are used on the opposing side of the entry.

Recommendations:

Also similar to the opposing side, reducing the number of species would help to “calm” the appearance of the entry. The moss rock boulders could also remain and having a consistent plant pallet would tie the two sides together providing continuity.

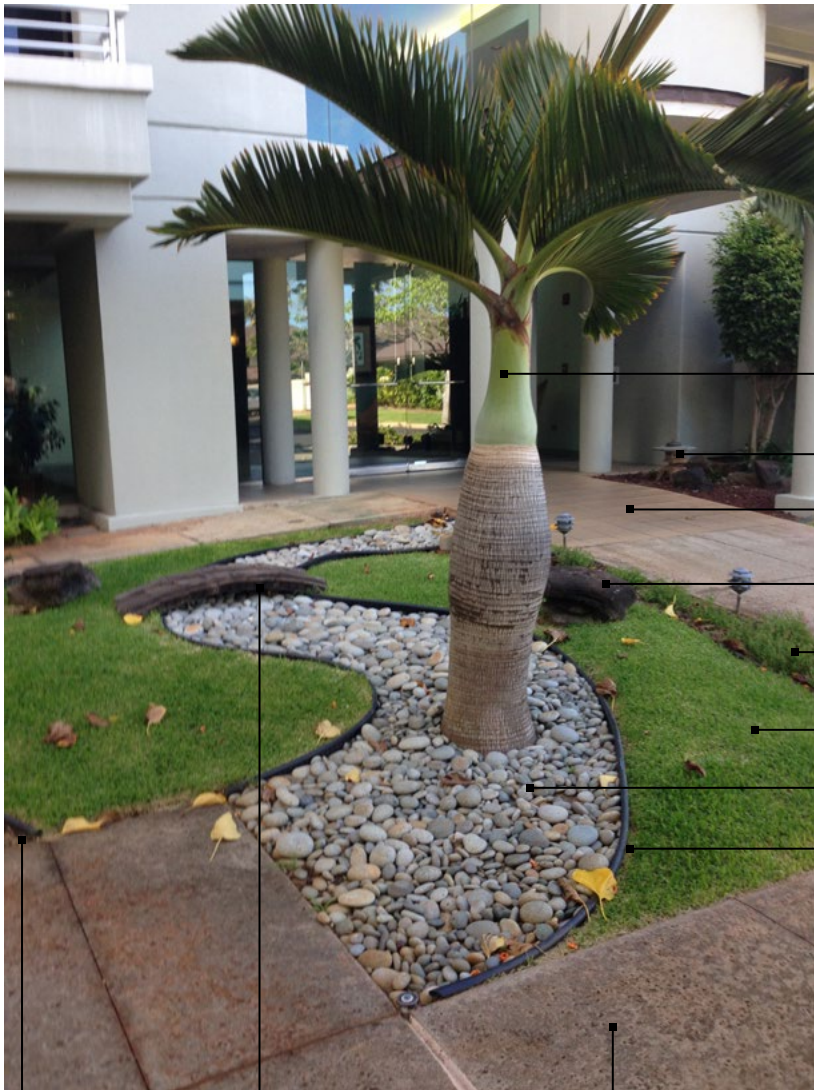
Building 2 Entry (L)

Observations:

This area takes a minimalist “zen garden” approach. A simple “river” of pebbles in lawn though lacking in dimension, texture and color. The “Japanese” bridge and lantern appear kitschy and out of place at their locations and the plastic header has an unflattering effect to the “river” concept. Small irregular lawn areas make for tedious maintenance.

Recommendations:

Add moss rock boulders for a raised planting area similar to opposing side and other building entries. Incorporate small shrubs and ground covers will add dimension, texture and color which will eliminate the need for frequent grass trimming. Changing pavers at the entry would update the look and feel and provide a warmer more appealing “welcome mat” to the doorway.

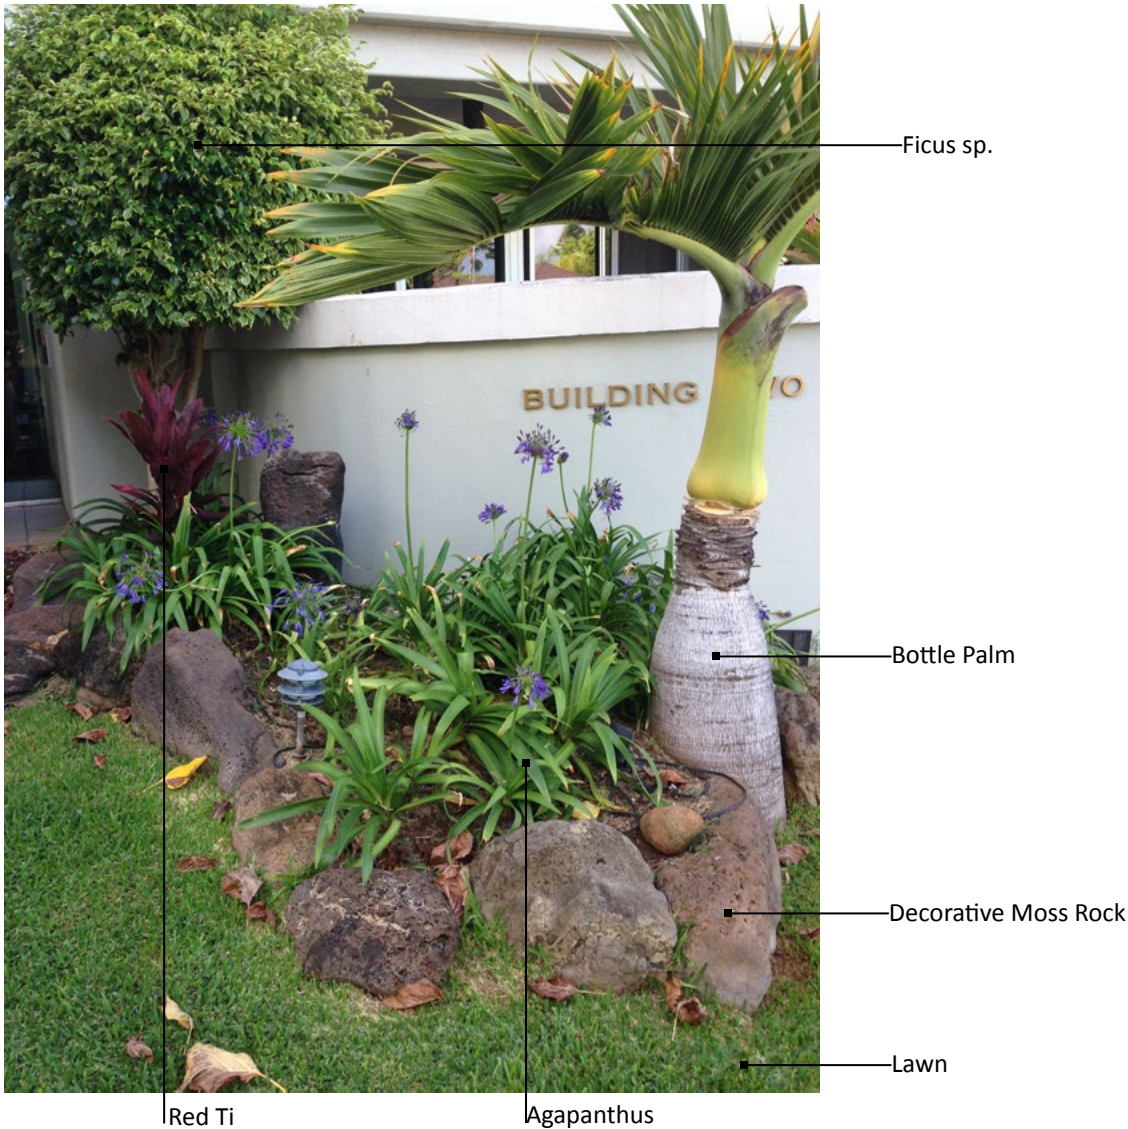
Building 2 Entry (R)

Observations:

The general moss rock locations are good, similar to building entry one, providing a raised planting area below the Building Two wall sign. This helps to highlight the sign and adds height dimension to the space. The plant combination and positioning of the Ficus and Bottle Palm seem to clash with each other. In time, the root system of the Ficus may damage the adjacent wall. The planting selection differs at both sides of the entry as there is nothing to tie the two together except the Bottle Palms.

Recommendations:

Remove the Ficus tree and replace with another plant with a mature height of 10'-12' to soften the corner. Replant raised area and use similar planting selection on opposing side. Removing Bottle palms are optional but recommended to update the look and feel of the entries. Use decorative river pebbles in front of the moss rock boulders eliminating the lawn and reducing maintenance. This will also help to tie the opposing side together.

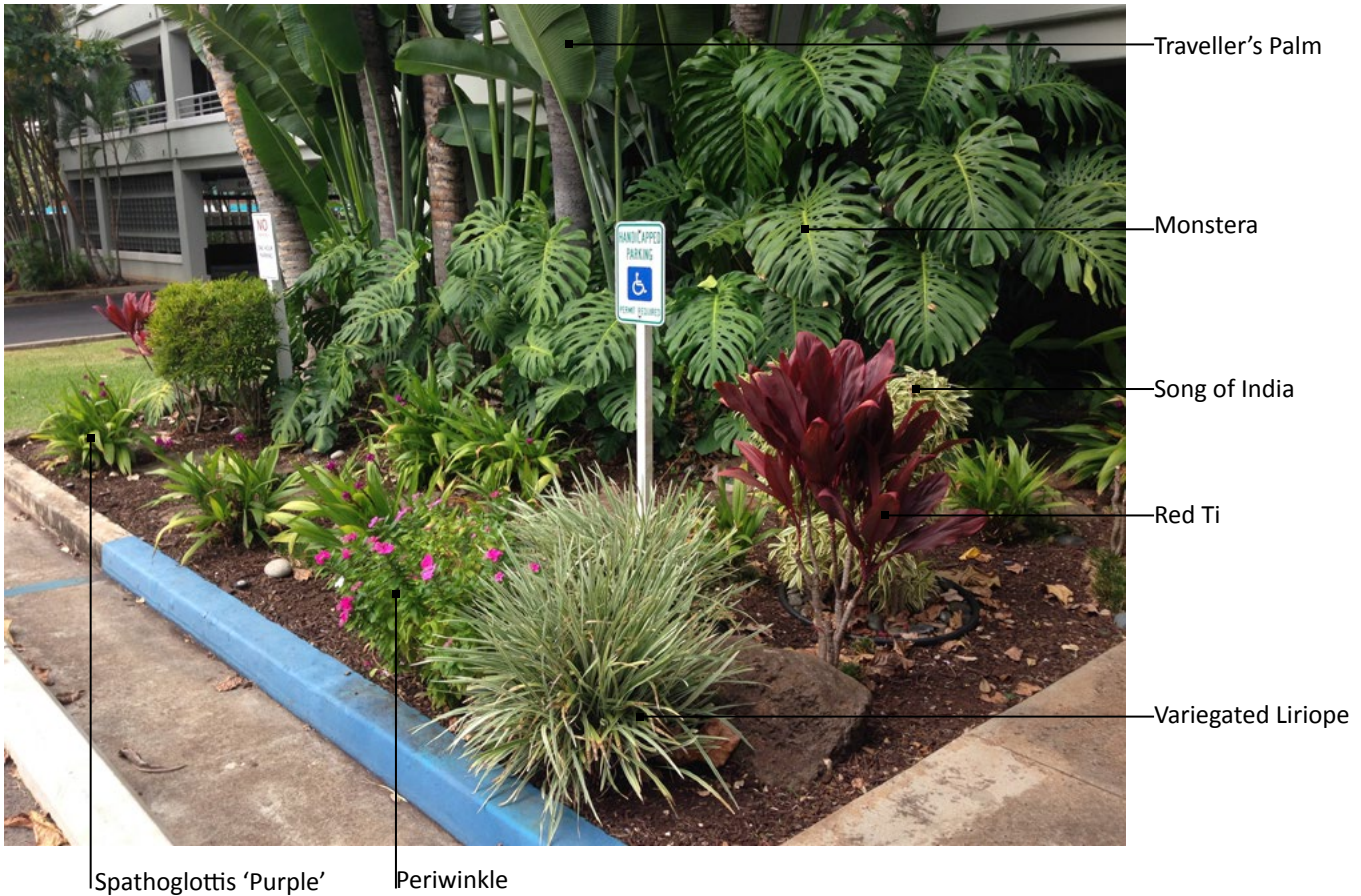
Building 3 Entry (L)

Observations:

This area has nice existing presence with the mature Traveler's Palms and Monstera. These provide scale to the building, shade screening. This is the largest planting area of the three entries and the most visible from the property's main entry. The general plant selection is good, but removing the "single" species and adding more of the others will provide a more sophisticated feel.

Recommendations:

The Variegated Liriope should be located further back just in the front along the edge of the Monstera. The Spathoglottis is a nice hearty plant that works well in the composition. If desired, the Periwinkle (vibrant pink flower). Red Ti and should be located at the outer edges of the composition. Song of India (behind Red Ti) should be removed. Add puka lava rock stepping stones in planter to fill out area, accompanied with decorative river pebbles. Add groundcover such as Mondo.

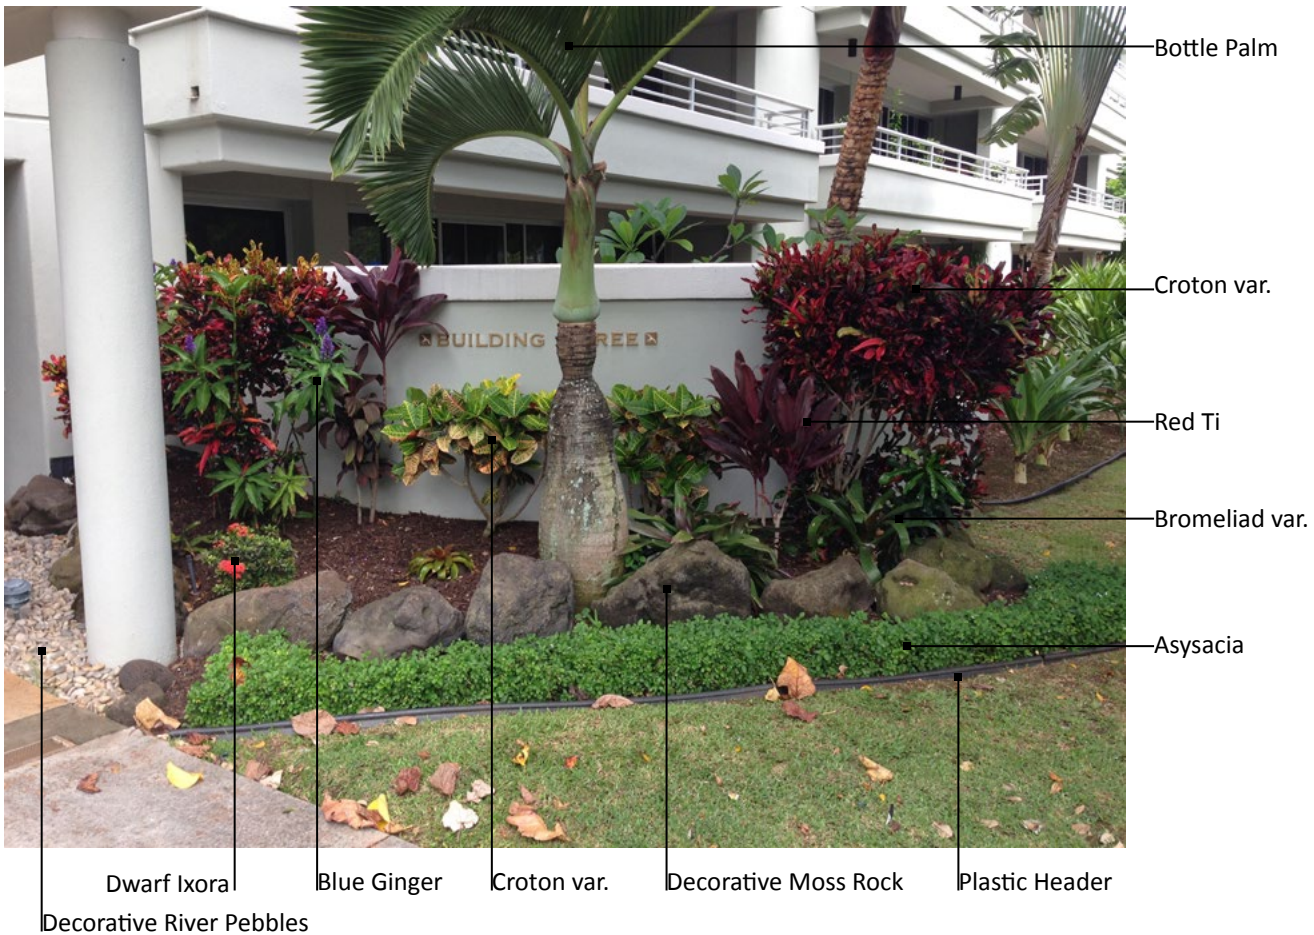
Building 3 Entry (R)

Observations:

This area's existing planting obscures the Building Three wall sign. The moss rock boulder positioning a size variation could be improved.

Recommendations:

Reconfigure moss rock layout similar to building entries One and Two. Incorporate similar planting pallet as opposing side. Remove Bottle Palm. Extend planter out further to reduce lawn area.

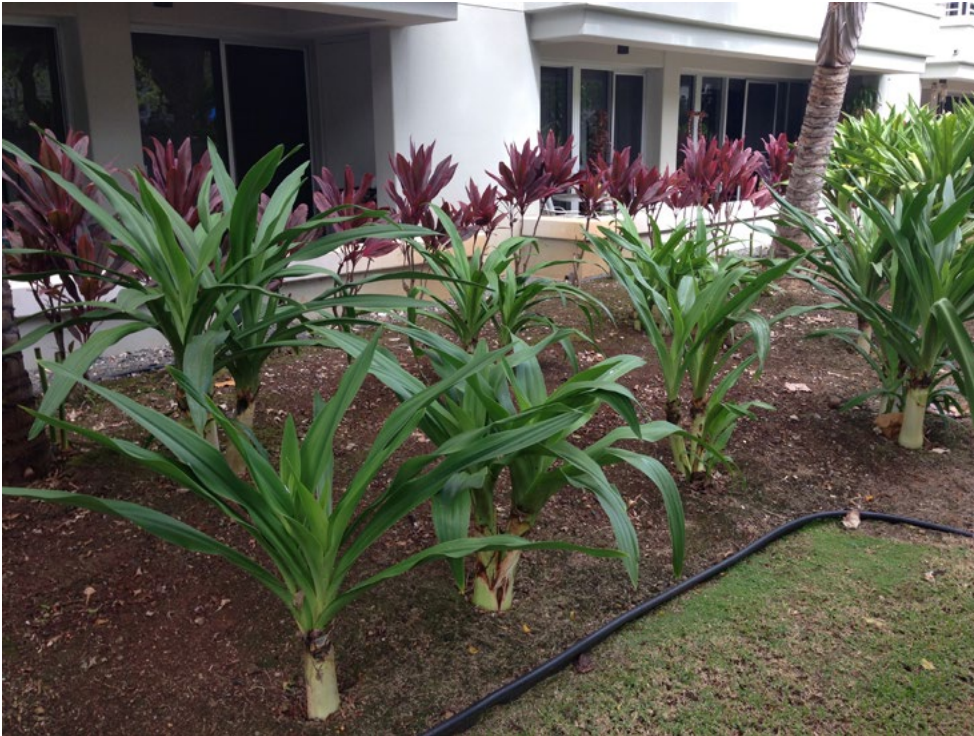
Conditions such as in this image is typical around the property where there is bare ground within a planter. The drainage is poor as indicated by the visible algae on the ground surface and probably low in nutrients and oxygen. As mentioned it is “Best Practice” to clear existing shrubs, grub and amend the soil, but a skilled landscaper could work around the existing shrubs to till up the biomass below the surface, amend the soil of necessary organic material and nutrients and add new planting. When replanting it would also help to add stepping stones or maintenance pathways in strategic locations to help minimize compaction of soil when working in the planters.

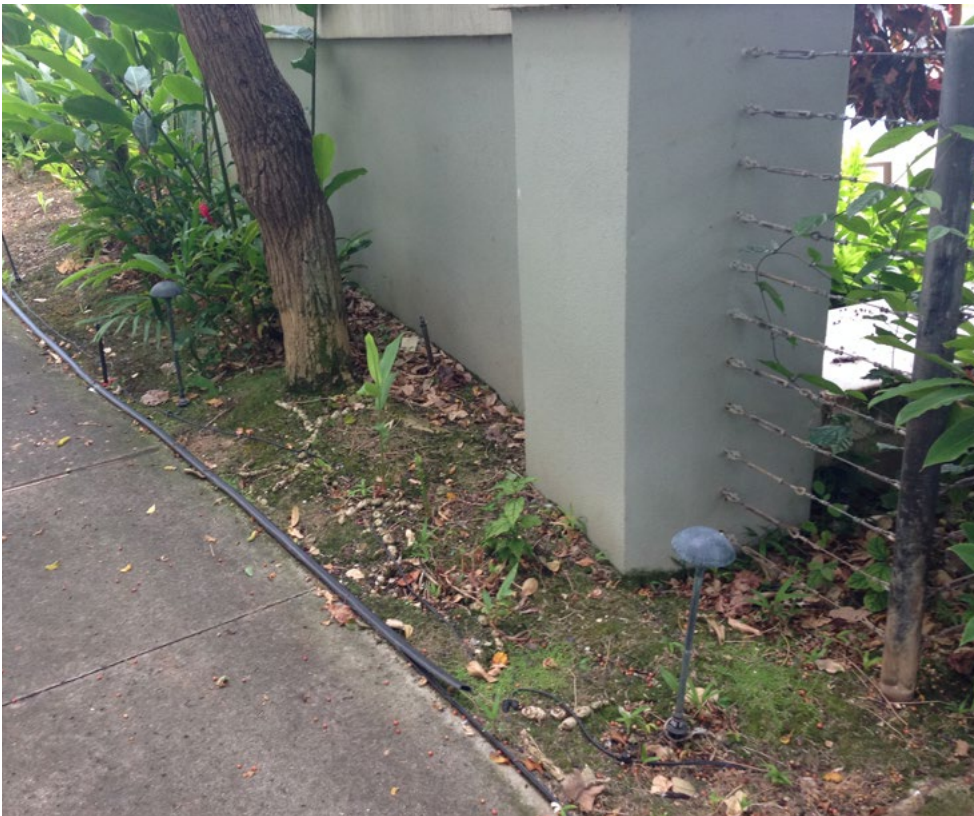
This is a similar situation where there is poor drainage and a lot of biomass at the surface of what is left of the soil. Root from the adjacent trees fill up the planting area and choke out the other plants. The tree roots may also compromise wall footings and side walks leading to costly repairs. In this particular situation it may be best to dig up and remove all biomass and replace with new planting media. If there is a low point with bad drainage and no drainage inlet to a sewer system, then a dry-well might be an option so ponding is minimized.

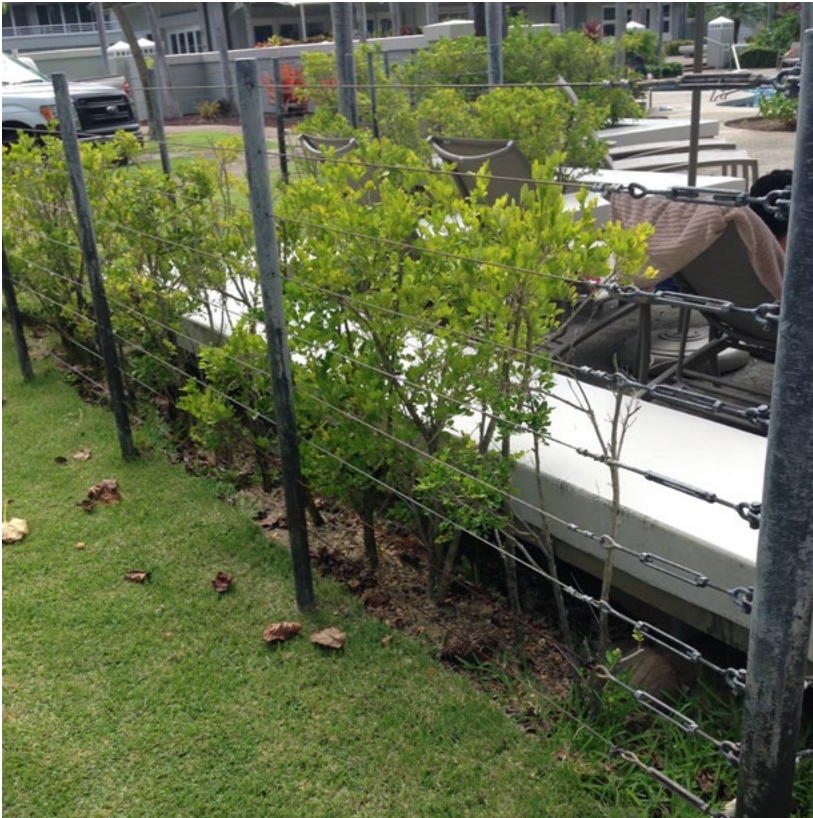
This area along the pool deck appears to have poor drainage as well. If this is an area where pool and deck water drains to then there may be chemical imbalances. Also if a string trimmer is used in the planter and the maintenance personnel isn't careful, there may be girdling of the Mock Orange leader stems. From the appearance of the leaf color, it appears that there is a lack of nutrients and poor drainage. Recommendations are to remove the existing planting material, excavate approximately 18" minimum and add organic material and nutrient amendments then replant desired plant species.

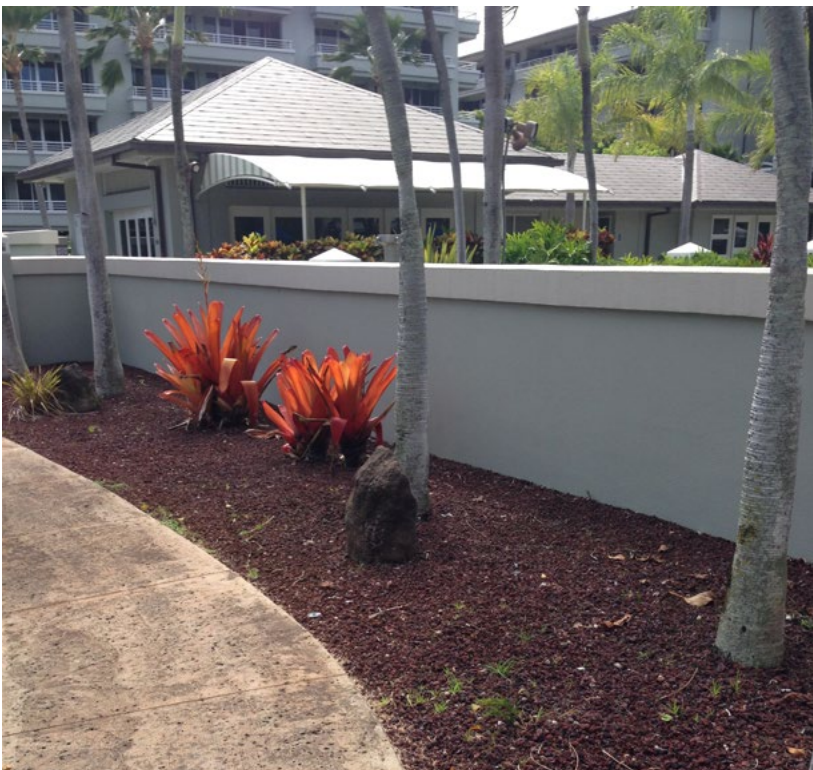
This planter adjacent to the guest parking and BBQ area could be potentially set up for an herb and vegetable garden. One idea is to construct raised planters between the palms (if they are to remain) with composite material "timbers" for containment of planting media, and ease of access for people that may have a difficult time bending down. Since this location has a direct and close vehicular access and is its proximity and relationship to the BBQ and eating area, this is an opportunity to make this planter a functional amenity.

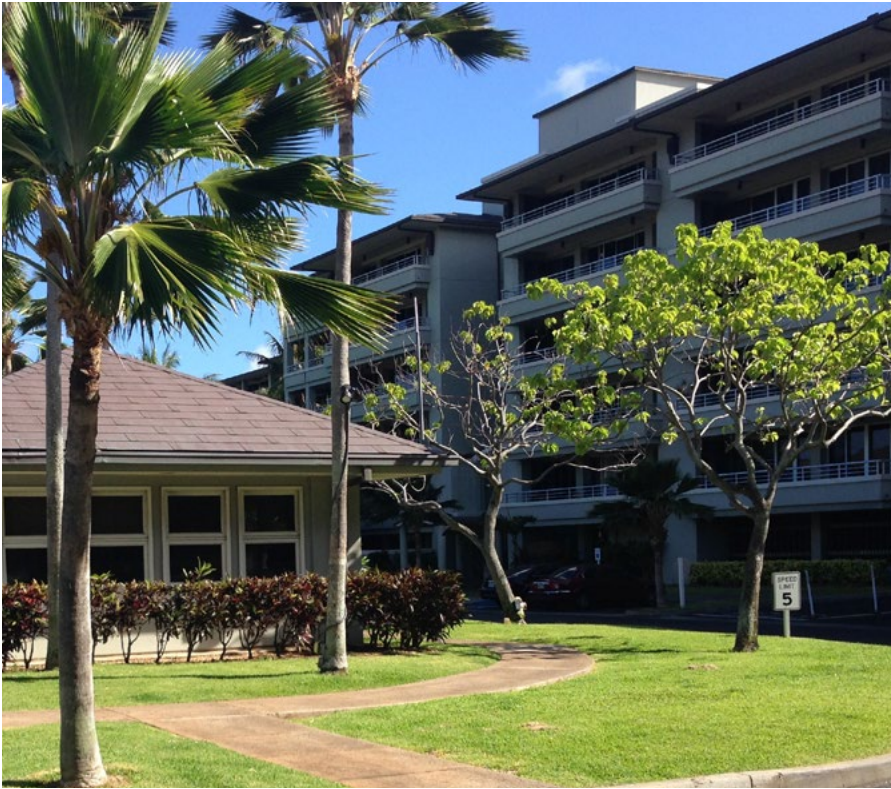
The property has a nice variety of specimen palms and trees. Some of the Kou trees around the office have died and are in decline. But just across the driveway others flourish. It's difficult to determine why this is. Reasons could be that the tree trunk cambium is being damaged by string trimmers. Or the roots are being bound in the tree pit with poor oxygen. Or the tree is somehow diseased. This would be best determined by a Certified Arborist but to reduce the potential of girdling, it's a good idea to mulch about 3' around the base of the trees and palms to keep the lawn away from the trunk base reducing the chance of the string trimmers to do any damage.

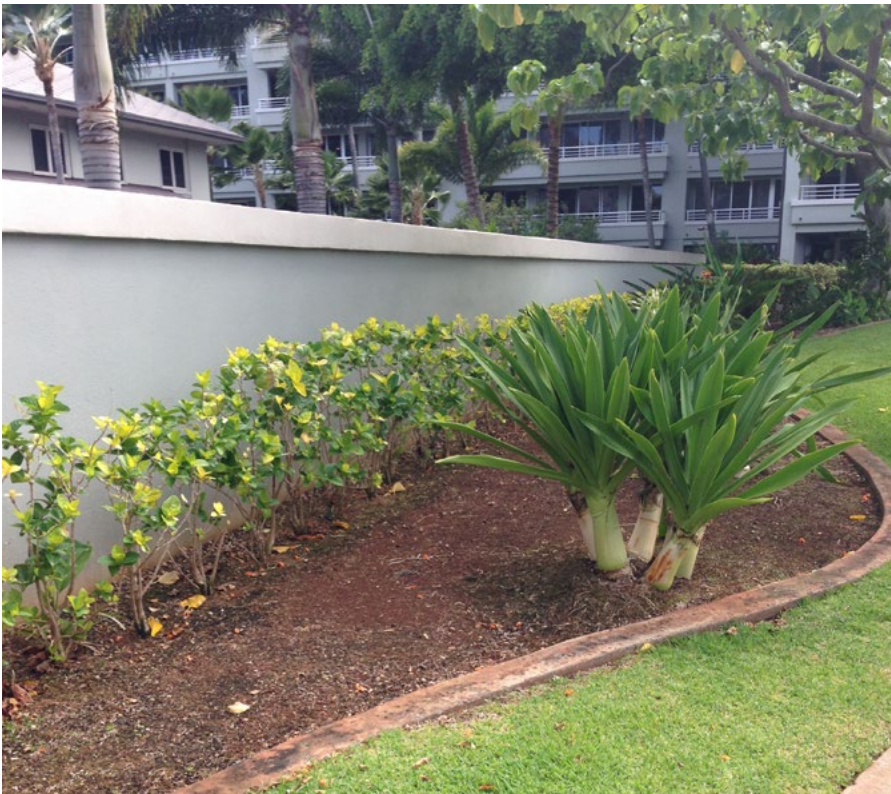
This planter along the wall of the town-homes shows obvious signs of poor drainage and low nutrients. Algae growth is visible and soil color has a red clay appearance. Only the Spider Lily seems to be not to be phased. Eldorado, the hedge planting, is typically quite hardy and can stand full sun to partial shade. It is doing well along Building One but still needs good drainage and adequate nutrients. Recommendation is to remove the existing planting material, excavate approximately 18" minimum and add organic material and nutrient amendments then replant desired plant species.

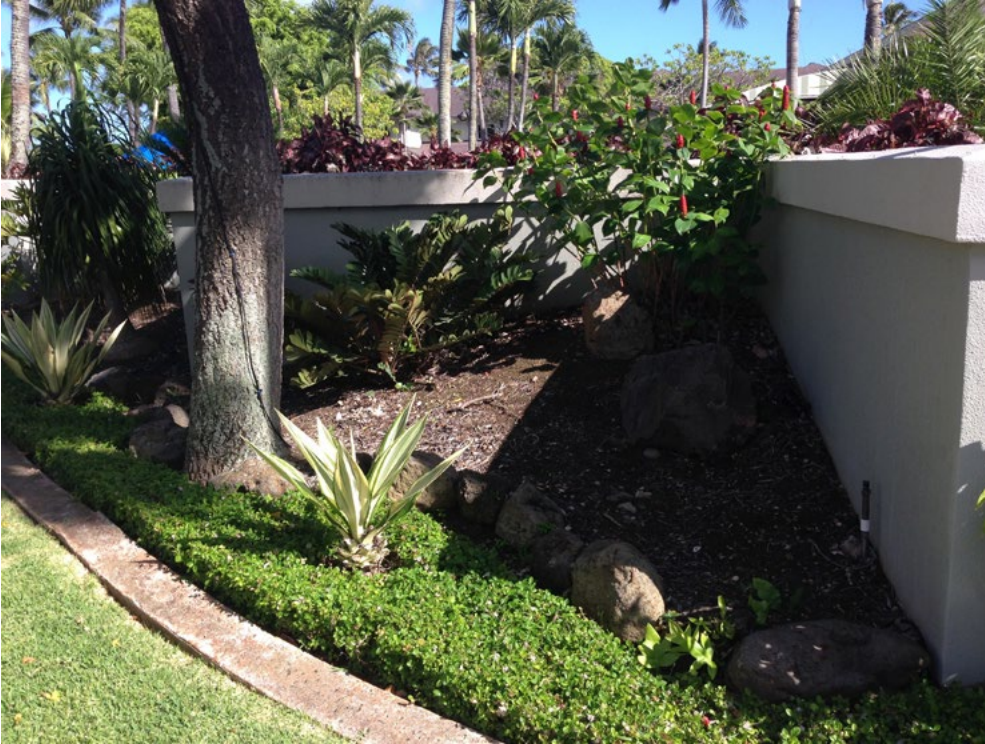
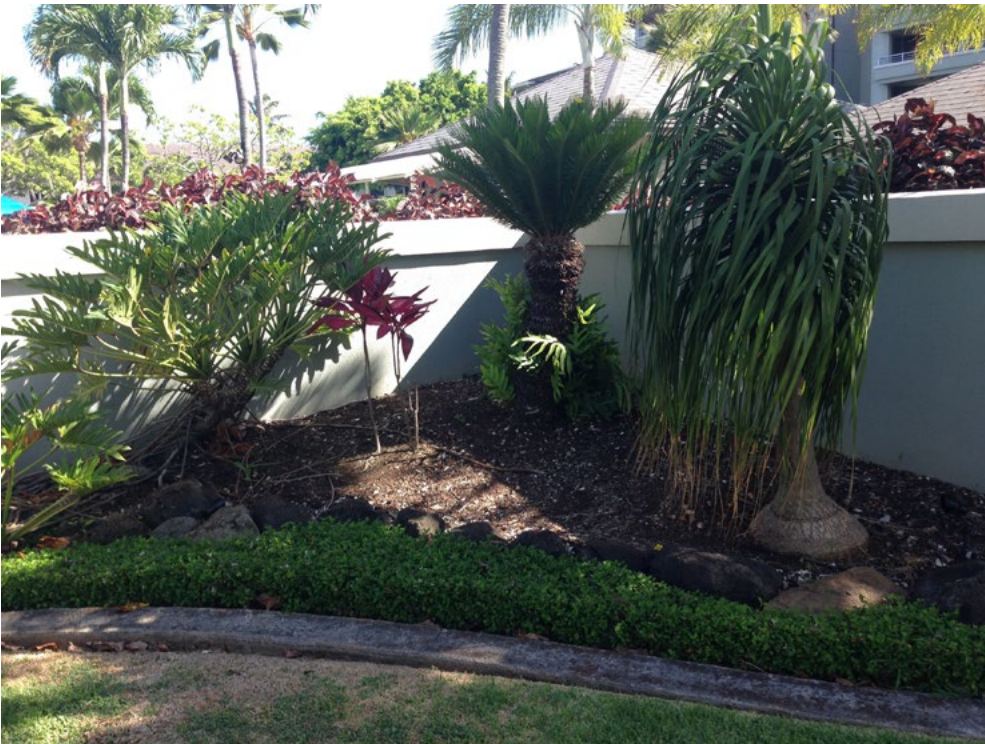
These two corner pocket planters at “Front door” have potential to have a nice composition. There are competing plant species “styles” and also have plants of similar heights which also is a competing factor. Soil again looks very poor. Recommendation is also to amend soil and improve plant composition by plant selection. Vary textures and add “pops of color.” Use repetition of plant species and plant in massing layering up from the wall down to low groundcover at the concrete header.

See Above
